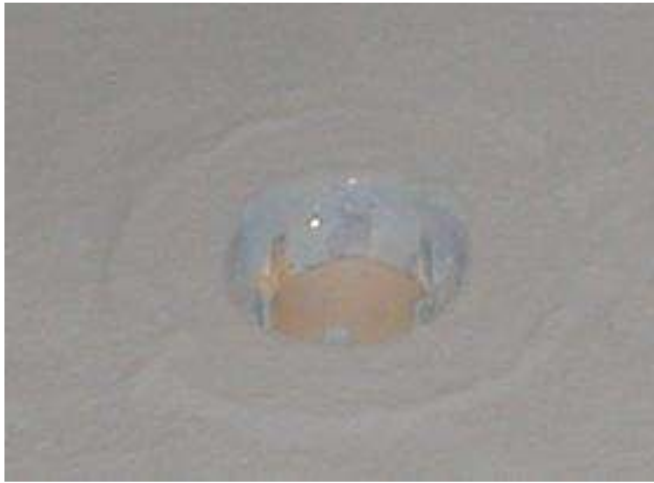
Close up of a Leak control flange & acrylic flexible membrane on a shower drain

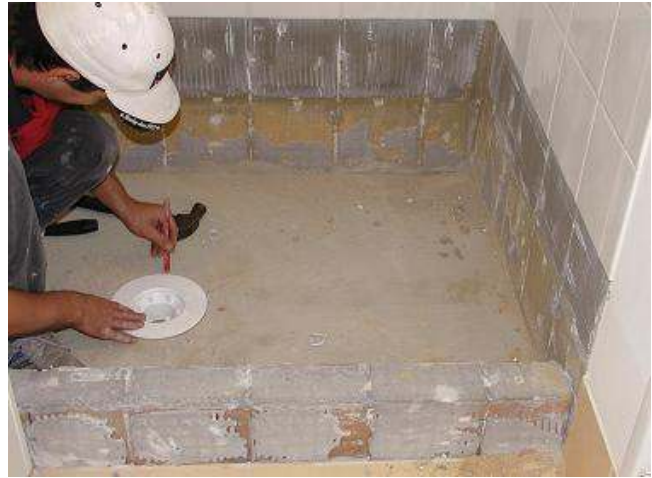
Fitting of a leak control flange

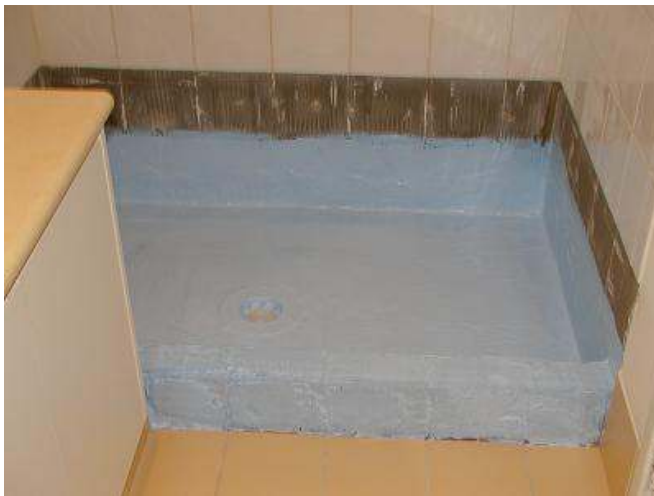
Leaking shower that has had the floor tiles and two rows of wall tiles removed. A Leak control flange has been fitted to the drain and the floor and wall have had Flexible waterproofing membrane applied.

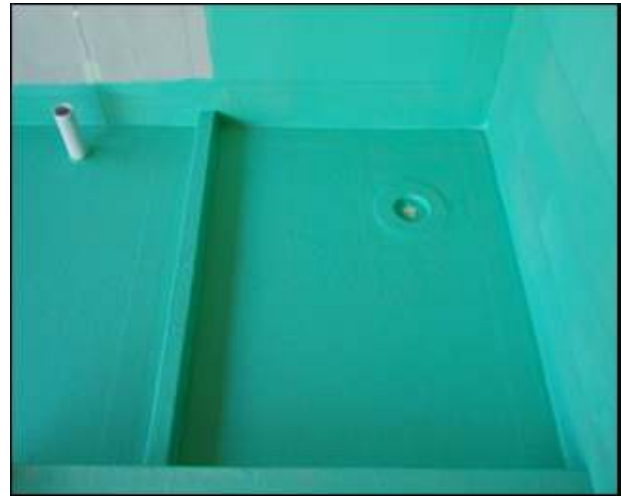
New shower recess where a Leak control flange has been fitted to the floor waste pipe and the floor & wall junctions reinforced with reinforcing bandage and finished off with Flexible waterproofing membrane.
